Background & Research Question

According to the 2022 Water Quality Report by Mayor Seth Fleetwood, Bellingham “throughout City government, [is] leading the way locally, regionally, and nationally in advancing new ideas and initiatives.” How do certain segments of this report compare to two separate tap water locations collected with our own equipment? We were thirsty to find out, and further analyze how this data compares to the 2023 City of Bellingham Common Water Quality Parameters. Finally, let’s set it to a national scale, and see if Bellingham’s data keeps up with the parameters of the National Drinking Water Regulations.

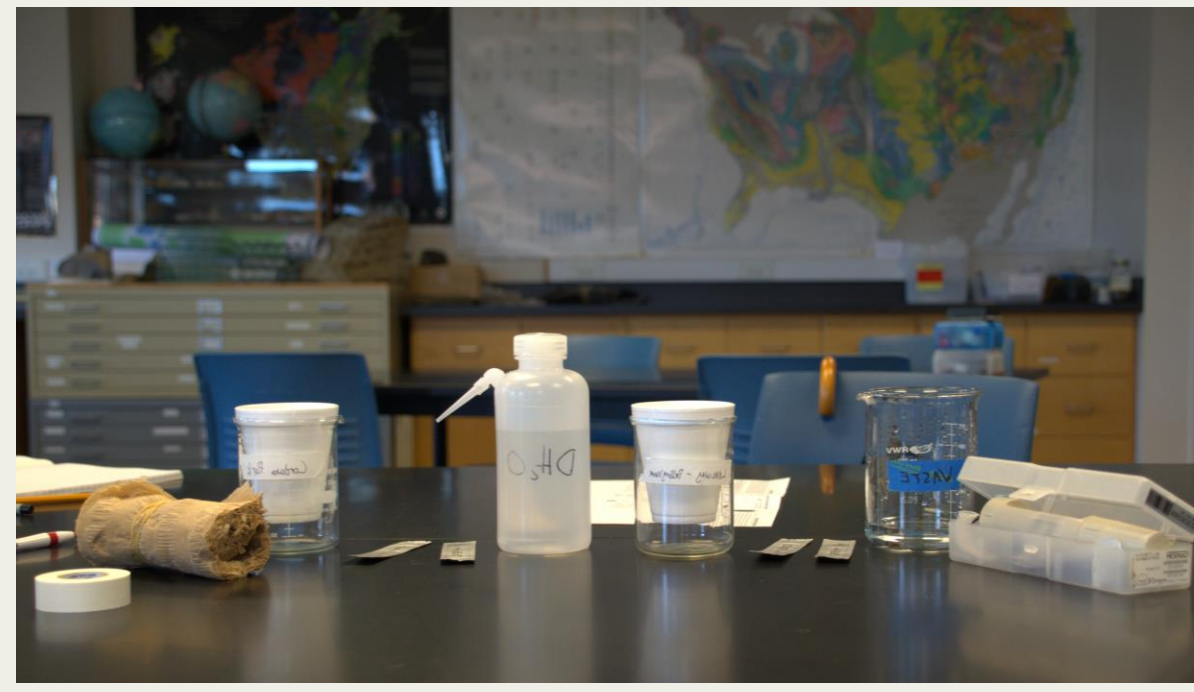
Figure 1. Materials used in experiment: x2 Styrofoam cups; x2 glass beakers; Eutech PCTest35 Probe Oakton, serial no. 2309389; LABTECH H2O OK Drinking Water Analysis Test Kit; Distilled water; masking tape; 'Low-cost Water Monitoring' tablet, by LaMotte

Materials fig 1 & Location fig 2a-b
